Manhole Inspection Summary

Manhole # S29GG1010MH

Location Address: **505 UNIVERSITY PKWY**

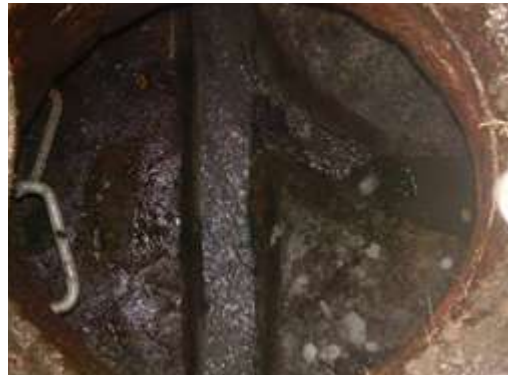
Top View

Surcharge ☒ **Evidence Of Surcharge** Depth: **1** (ft.) ☐ Active Surcharge Present

Evidence of surcharge - Bench debris.
Channel debris.

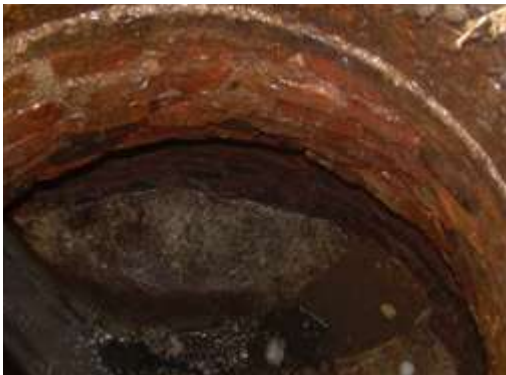
Defect

Frame Offset: **0** (in.) Condition: ☐ Sound ☐ Cracked ☒ **Leaks**

Condition: ☐ Sound ☐ Cracked ☐ Root Intrusion ☐ Loose Brick ☒ **Deteriorated**

Infiltration: ☐ None ☒ **Joint** ☐ Cracks ☒ **Mortar** ☐ Roots ☐ Wall

Infiltration: ☐ None ☐ Joint ☐ Cracks ☒ **Mortar** ☐ Roots ☒ **Wall**

Frame leaks. Adjustment deterioration
and infiltration. Barrel infiltration.

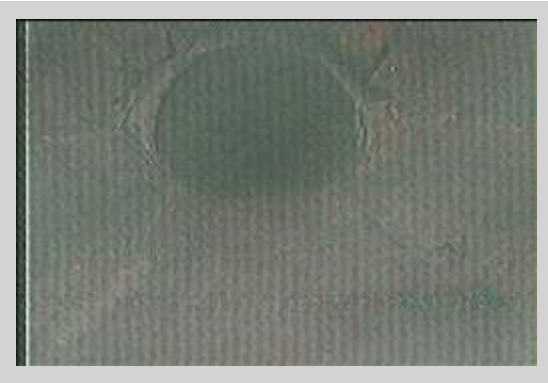
8 in. Circular Gravity Sewer Pipe Out @ 12 O'Clock

Infiltration: **Evidence** Pipe Seal Cond: **Cracked**

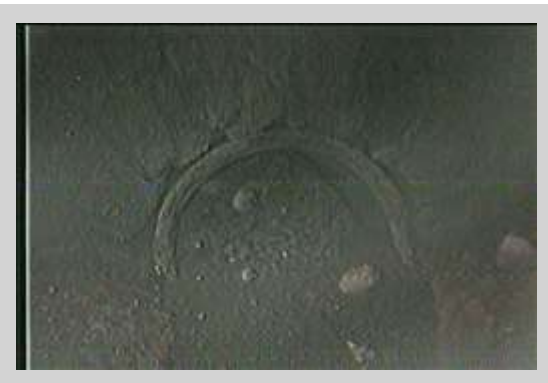
6 in. Circular Gravity Sewer Pipe In @ 3 O'Clock

Infiltration: **Evidence** Pipe Seal Cond: **Broken**

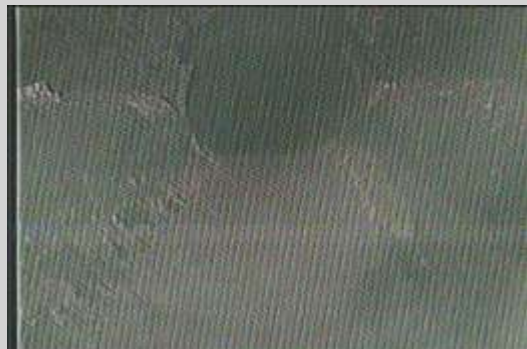
Pipe In @ 6 O'Clock

Infiltration: **Evidence**

Pipe Seal Cond: **Broken**
